State of California — The Resources Agency
 DEPARTMENT OF PARKS AND RECREATION
PRIMARY RECORD

*Resource Name or Address 508/510 F Street
 P1. Other Identifier: None
 *P2. .Location: *a. County Yolo
 b. Address 508/510 F Street
 *c. City Davis Zip 95616
 d. UTM: N/A
 e. USGS Quad: Davis Quadrangle
 *f. Other Locational Data (APN #): 070-194-007

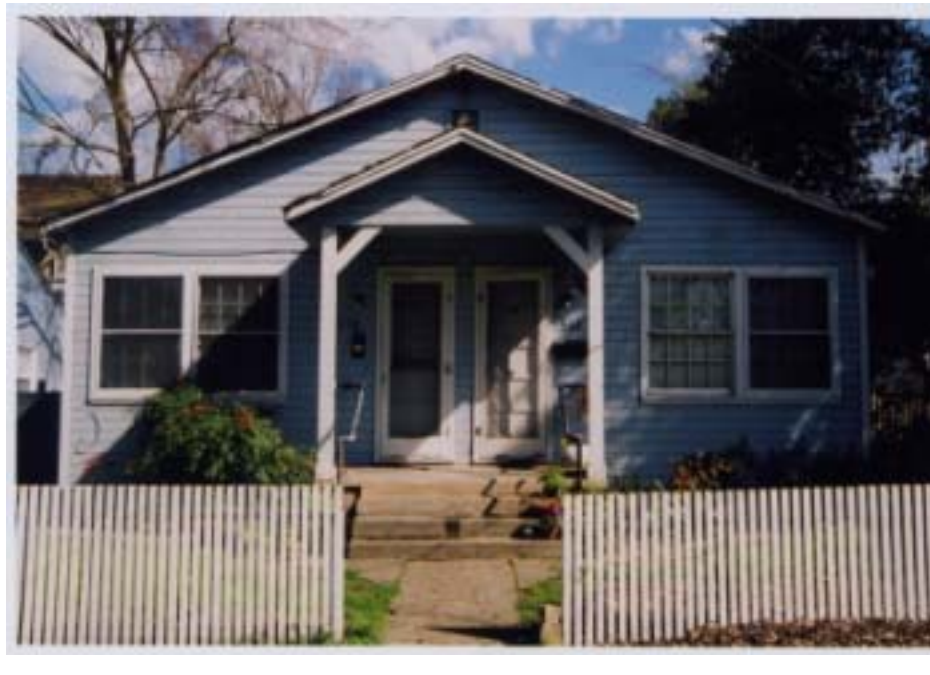
P5. Photograph or Drawing (Photograph required for buildings, structures, and objects.)

According to John Lofland (*Old North Davis*, Yolo County Historical Society, 1999), this double bungalow was originally a single family dwelling constructed in 1929 and converted in 1940. It is rectangular in plan with a moderately pitched front gable roof. Gable and eave overhangs are minimal with dipped ends. This uncharacteristic bungalow treatment may be the result of the later alteration. The gable end is trimmed with an arrow fascia, as is the gable end of the porch roof. A central, gable roofed projecting porch is centered on the façade, framing the side-by-side duplex entry doors. The porch roof is supported on braced 2X4s. The porch appears to be a replacement, possibly added in 1940. It is not possible to discern the configuration of the original porch or if it has been enclosed to create the flat façade that the building presents to the street. Fenestration consists of eight-over-eight double hung windows. The pairing of these windows lends a strong horizontal emphasis to the front façade. The window sash and glazing are original, but it is unclear if their position was changed to accommodate the conversion in occupancy. The conversion of the house and the accompanying alterations to the porch, entry doors, and possibly the front façade, fall within the period of significance. Therefore, the house retains the integrity of the 1940 building. It appears to be unaltered and it contributes to a district eligible for the California Register.

View east
