State of California — The Resources Agency  
 DEPARTMENT OF PARKS AND RECREATION  
**PRIMARY RECORD**

\*Resource Name or Address 519 F Street  
 P1. Other Identifier: None  
 \*P2. Location: \*a. County Yolo  
 b. Address 519 F Street  
 \*c. City Davis Zip 95616  
 d. UTM: N/A  
 e. USGS Quad: Davis Quadrangle  
 \*f. Other Locational Data (APN #): 070-183-012

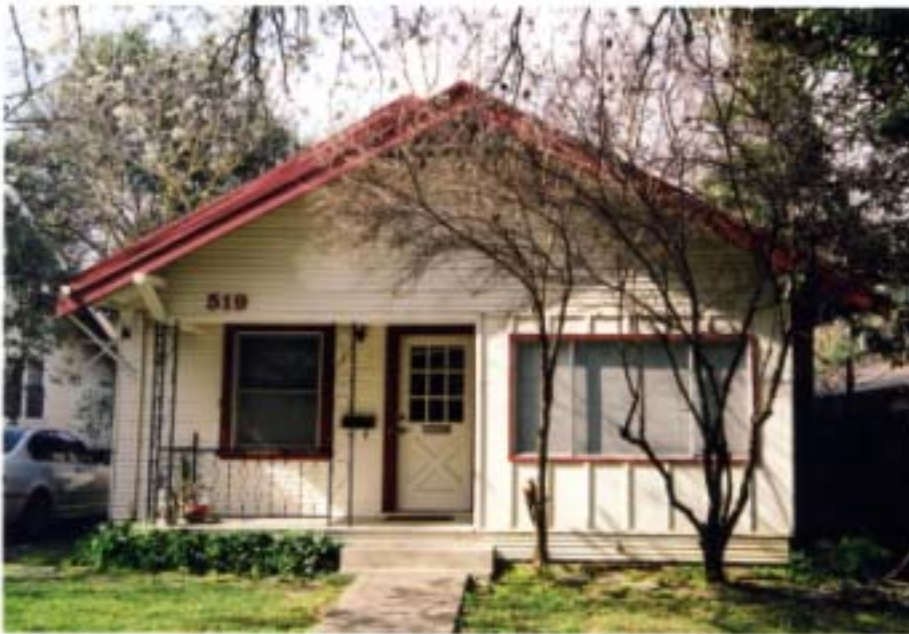
P5. Photograph or Drawing (Photograph required for buildings, structures, and objects.)

\*P3a. Description:  
 This bungalow exhibits double front-facing gables. The projecting front gable is unusually wide and originally covered a full length porch. Overhangs are moderate and are supported in the front and on the sides by knee brace brackets. Exposed rafter tails provide decorative detail on the eaves. Fenestration consists of one-over-one double hung windows, except on the north side of the front façade. The original porch has been enclosed and a large, metal frame window has been inserted. The south half of the porch remains open, but the original porch columns and rail have been replaced with modern wrought iron posts and rail. The enclosed portion of the porch is clad with board and batten, while the rest of the structure, including the gable end, is covered with narrow, novelty siding. The entry also door has been replaced with a partially glazed and paneled door of a style typical in 1950s Ranchers. Although the house retains its original massing, form and roof line, the enclosure of the porch, alteration of the front window and removal of porch supports and ornament has substantially affected the integrity of design, materials, and workmanship. The house does not contribute to a district eligible for the California Register.

View west  
 \*P6. Date Constructed/Age:  
 c 1920 83 years old estimated  
 Prehistoric  Historic  
 Both  
 \*P7. Owner and Address:  
 Raphael Moore  
 35895 Yellowstone Ave  
 Davis, CA 95616  
 \*P8. Recorded by:  
 Carol Roland  
 Roland-Nawi Associates  
 4829 Crestwood Way  
 Sacramento, CA 95822  
 \*P9. Date Recorded: 04/07-10/2003  
 \*P10. Type of Survey:  Intensive  
 Reconnaissance  Other  
 Describe: Determination of  
 Local District Eligibility  
 \*P11. Report Citation: none  
 \*Attachments:  NONE  Map  
 Sheet  Continuation Sheet   
 Building, Structure, and Object Record  
 Linear Resource Record   
 Archaeological Record  District  
 Record  Milling Station Record   
 Rock Art Record  
 Artifact Record  Photograph
