**\*P11. Report Citation:** Davis, California: Citywide Survey and Evaluation of Buildings Constructed Prior to 1976

State of California — The Resources Agency  
 DEPARTMENT OF PARKS AND RECREATION  
**PRIMARY RECORD**

\*Resource Name or Address 622 E Street  
 P1. Other Identifier: None  
 \*P2. .Location: \*a. County Yolo  
 b. Address 622 E Street  
 \*c. City Davis Zip 95616  
 d. UTM: N/A  
 e. USGS Quad: Davis Quadrangle  
 \*f. Other Locational Data (APN #): 70-182-005

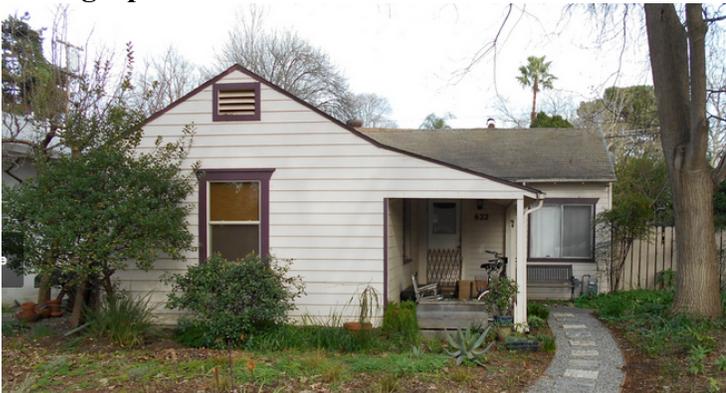
**Photographs:**

**\*P3a. Description:** The 2003 inventory described this building as “unaltered.” Information subsequently provided by the building’s owners (historic photographs, Yolo County building records, and Sanborn maps) at the July 20, 2015, City of Davis HRMC meeting indicated that the building has been heavily altered several times. The main side gable portion of the house was constructed prior to 1921, either on location or off-site and later relocated. The building was expanded to the north and east in the 1930s. The major projecting west wing and patio were added in 1948. At that point, the main entrance to the building, which had previously been on the south facade, was shifted to the west beneath the patio covering. The last addition, a rear wing not readily visible from the street, was added in 1964. The only apparent change since the 2003 survey was the removal of wooden shutters around the front windows to be replaced with decorative trim.

While this building has been heavily altered, the major visible changes all occurred within the early post-war period. Overall, this building well exemplifies what Davis historian John Lofland has described as “the mobile and complex history” of Old North Davis homes. This building retains its post-war integrity of materials and ad-hoc design, and continues to contribute to the historical character of the Old North Davis neighborhood.

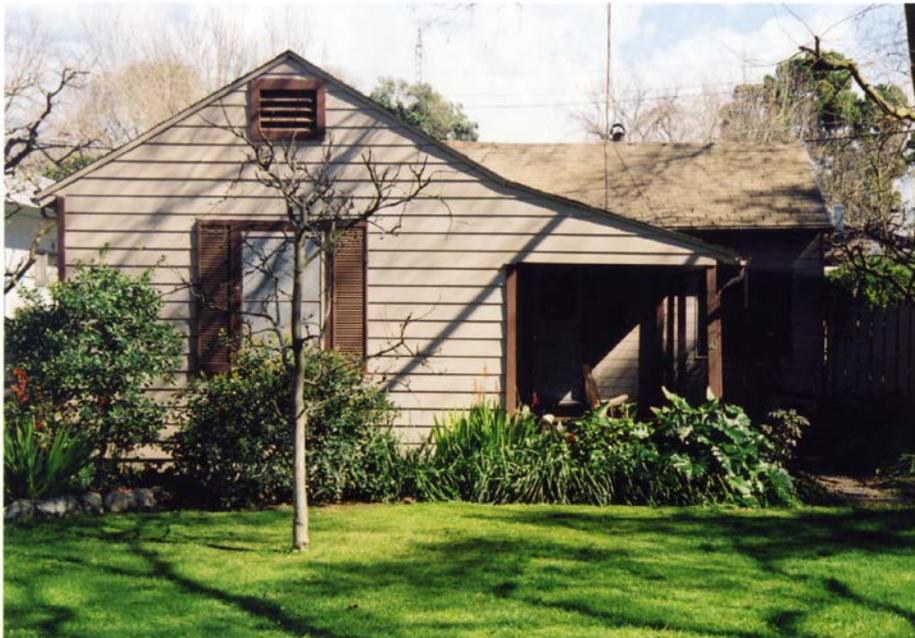
P5. Photograph or Drawing (Photograph required for buildings, structures, and objects.)

\*P3a. Description:  
 This Minimal Traditional house has a complex plan which stair steps back from the street in three distinct bays. The L-shape central structure has a cross gable roof. There is a projecting front gable wing, a central side gable wing, and a third bay which attaches to the south wall of the house and has a separate and lower elevation gable roof. The front porch of the house is oriented toward the south (side) of the house and is covered by a long extension of the eaves of the front wing roof. Fenestration is varied and includes both double hung and casement windows. It is clad with composition clapboard siding. The house was constructed in 1932. Despite the change in cladding, the house retains its integrity of design, workmanship, setting, location, feeling and association. It appears to be unaltered and it contributes to a district eligible for the California Register.

\*P3b. Resource Attributes: HP2  
 \*P4. Resources Present:  Building  Structure  Object  Site  District  Element of District  
 P5b. Description of Photo:  
 View east  
 \*P6. Date Constructed/Age:
