State of	California	a — The	Resc	urces	Agency
DEPART	MENT OF	PARKS	AND	RECRE	ATION
PRIM	ARY F	PECO	RD

529 F Street *Resource Name or Address

*P3a. Description:

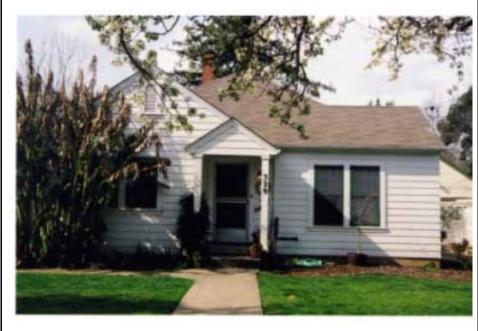
P5. **Photograph or Drawing** (Photograph required for buildings, structures,

This L-plan cottage has a hip on gable principal roof, with a front projecting cross gable on the south side. This multiplicity of roof heights and intersections provides visual interest to the otherwise simple house. Unfortunately the varied roof line is played down by the untextured composition shingle replacement covering. Gables and eaves are clipped. The front projecting gable is finished with a half circle vent and a molded facia; this latter also found on the projecting porch gable. Both facia feature eturns. This treatment suggests a Colonial Revival influence in a house that otherwise models the form and botprint of the Minimalist Traditional houses popular at the time of its construction. Windows are double hung, multi-light cottage types of varying sizes. Those on the front façade are strongly vertically emphasized and are arranged in pairs. The entry is set back into the L formed by the intersection of the south wing and the principal block of the house. This recession is emphasized by the addition of a slightly projecting porch gable, supported on wooden posts. Cladding is dapboard which also contributes to the Colonial feeling of the house. The integrity of design, materials, workmanship, setting, location, feeling and association are etained. The house contributes to a district eligible for the California Register.

View west
